Summary Report of the Vadose Zone Soil Sampling in the
Bazile Groundwater Management Area
2014-2016

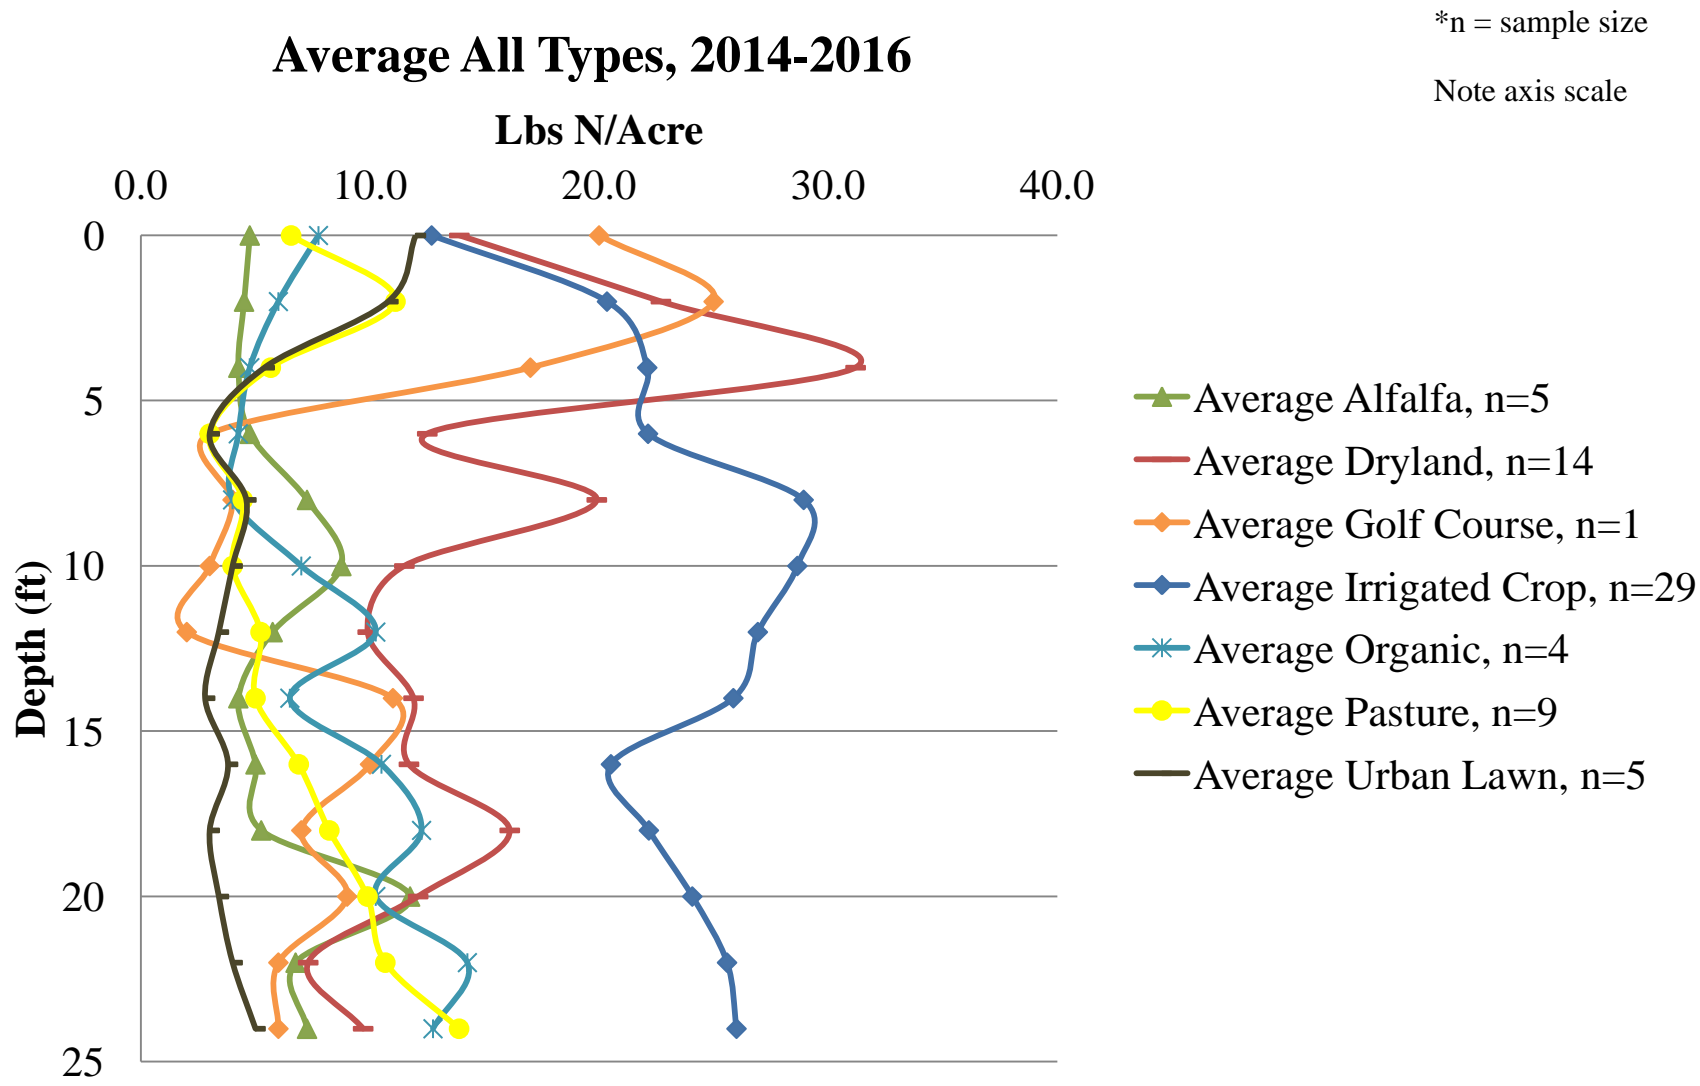
Figure 4: Summary Graph – Average for all Management Types

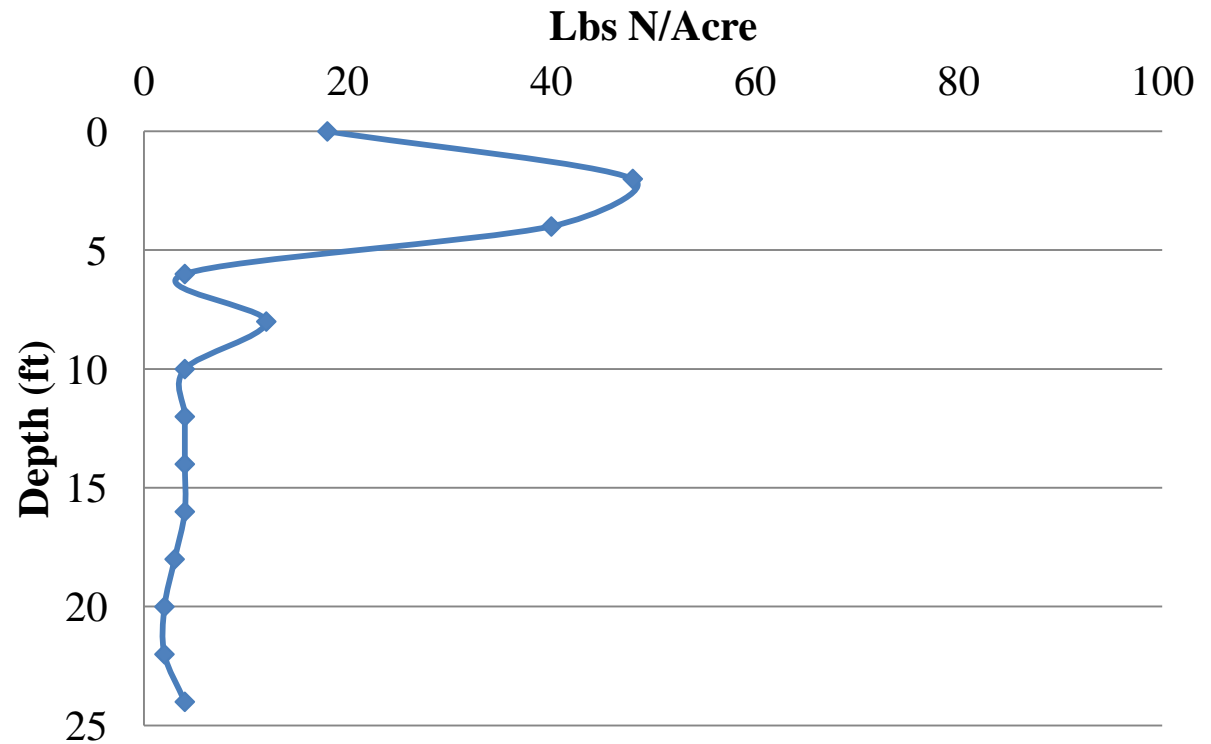
Figure 21: Site D5

Depth (ft)	Texture by Feel	Lbs N/Acre
0	Loam	18
2	Loam	48
4	Clay Loam	40
6	Sandy Loam	4
8	Sandy Loam	12
10	Loamy Sand	4
12	Sand	4
14	Sand	4
16	Sand	4
18	Loamy Sand	3
20	Loamy Sand	2
22	Sand	2
24	Sand	4
Total lbs N/acre 149 for Core

Management Details: Sampled 11/21/14. Producer split applies nitrogen during the season. This field has been in no-till management since 1997. Location also sampled in 2016, see sample D11.

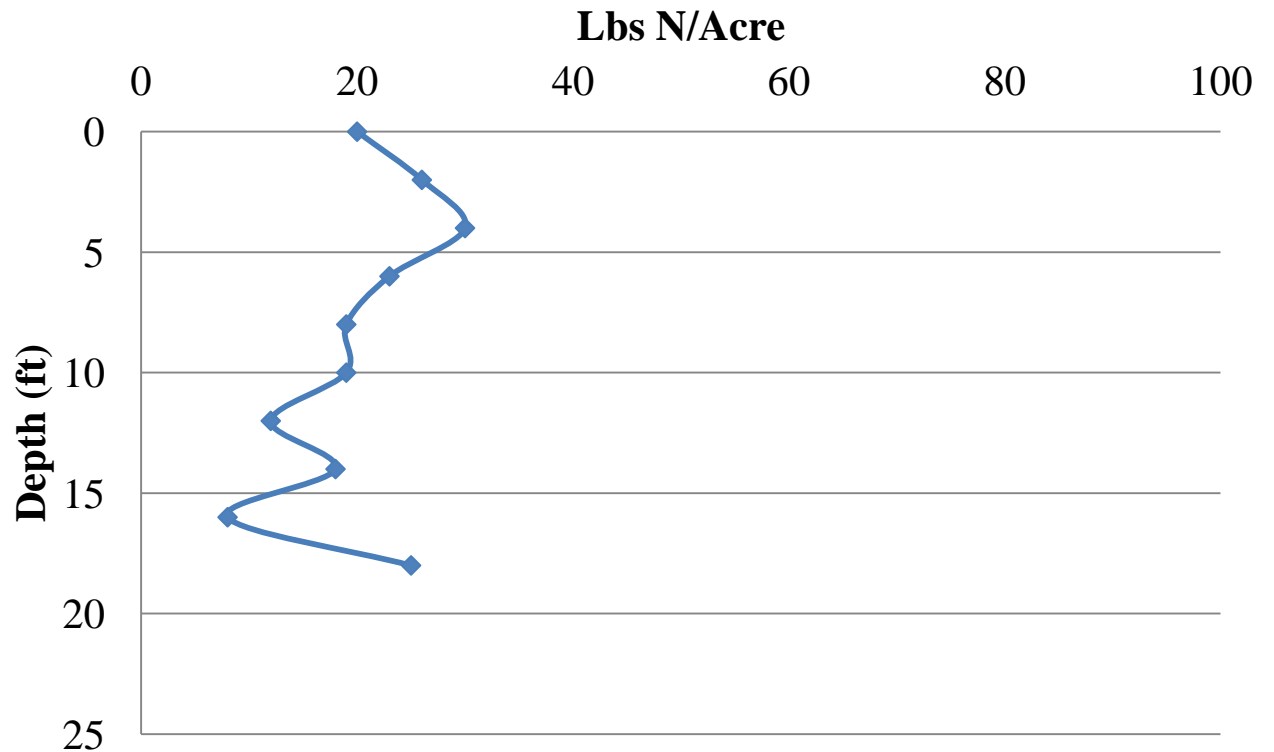
Figure 24: Site D8

Depth (ft)	Texture by Feel	Lbs N/Acre
0	Loam	20
2	Clay Loam	26
4	Clay Loam	30
6	Loam	23
8	Loam	19
10	Loam	19
12	Sandy Loam	12
14	Sandy Loam	18
16	Loam	8
18	Loam	25
20	N/A	
22	N/A	
24	N/A	
Total lbs N/acre 200 for Core

Management Details: Sampled 12/5/14. This sample was taken from an area that has been dryland farmed for 50+ years. Field was currently in soybeans. Water prevented further sampling below 18 feet.
